Academy Hill Monument
Stratford, Connecticut

December, 2016

Conservation Treatment Report

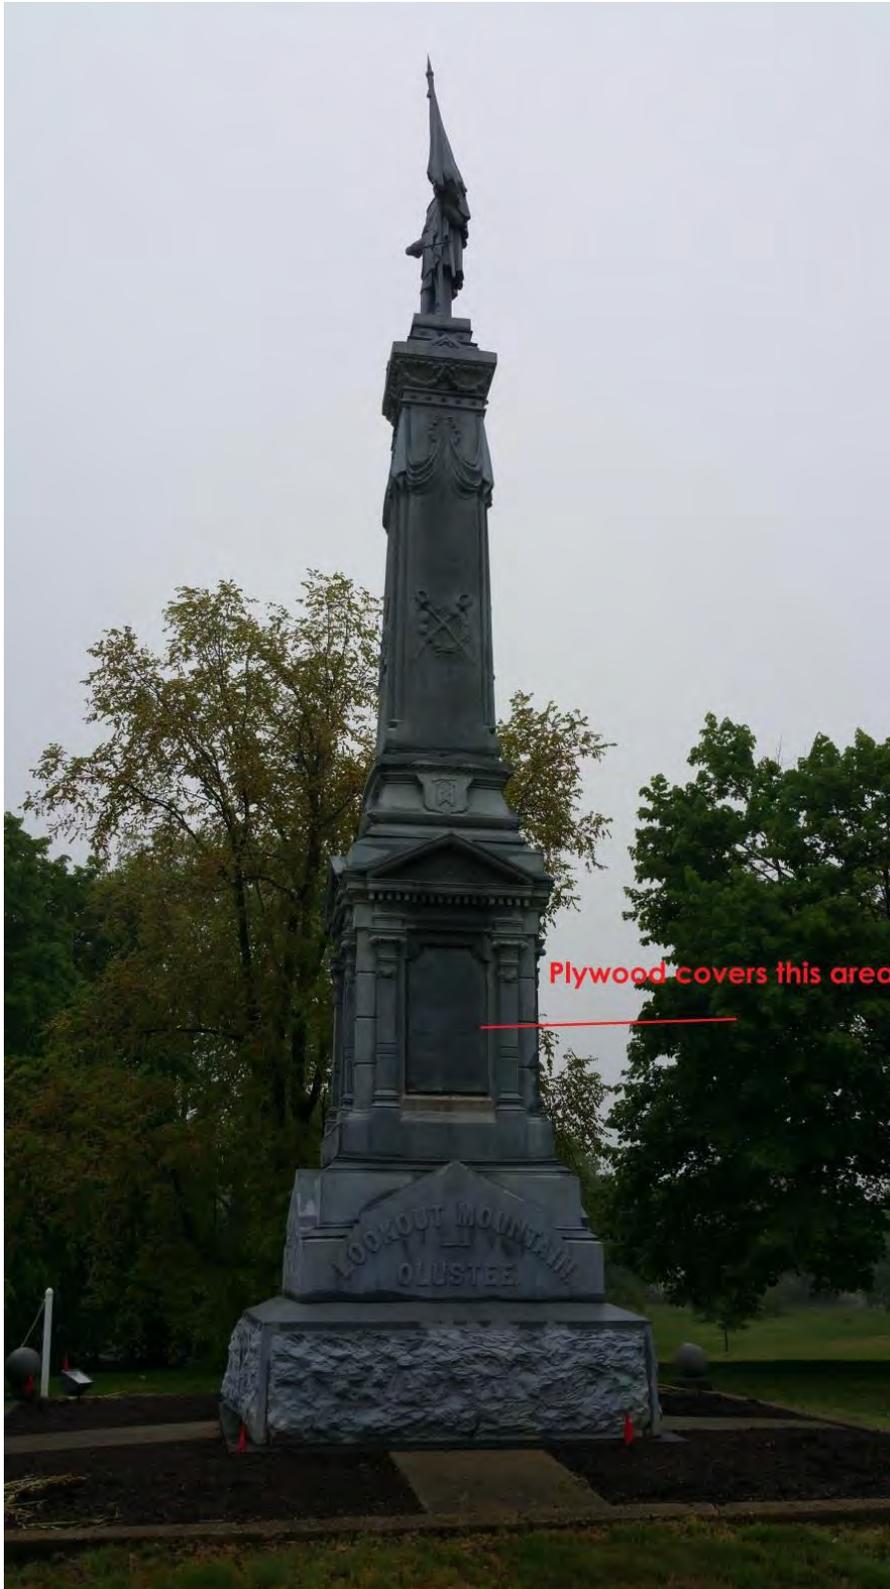
Figure 1 Before treatment, general view

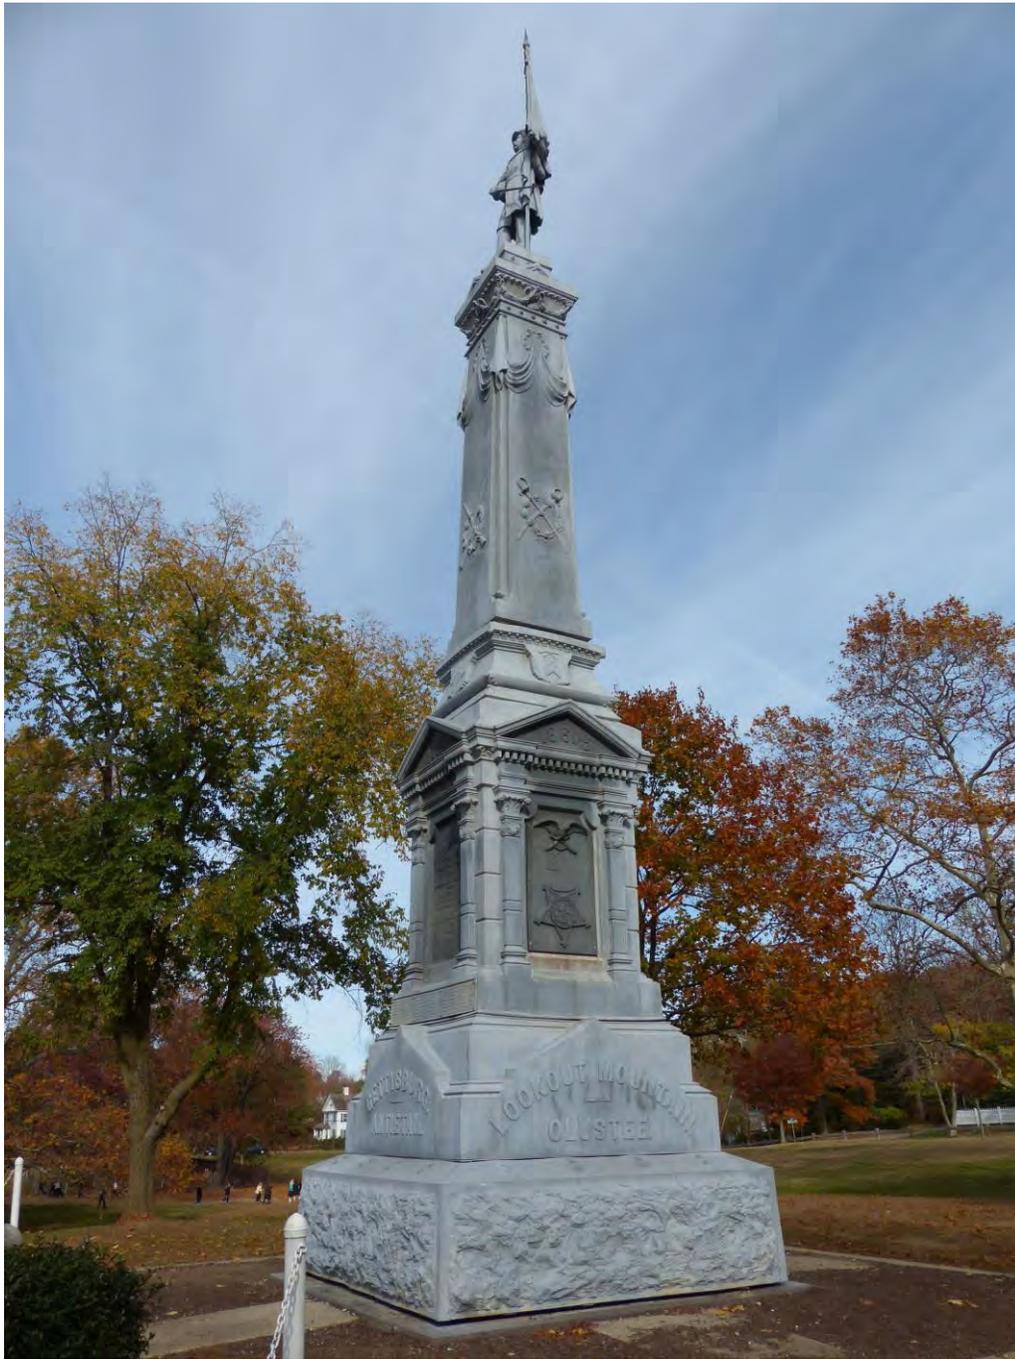
Figure 2 The monument after treatment, general view
