## Academy Hill Monument – Assessment Report

WEI Job No. 14-1368  
ACADEMY HILL MONUMENT  
STRATFORD, CONNECTICUT

MONUMENT DETAILS

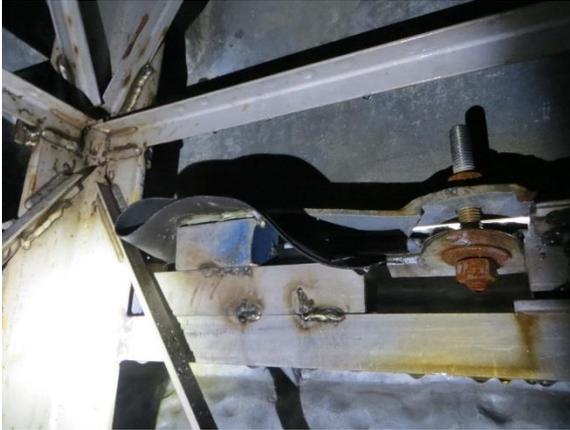
The armature has minimal contact with the monument's zinc pieces. The connection between the monument and armature is made through the use of stainless shims with no permanent connections. In several locations the shims were easily moved by hand.

Interior view of stainless tower, shim blocks and connection bolt, joint between Sections 3B and

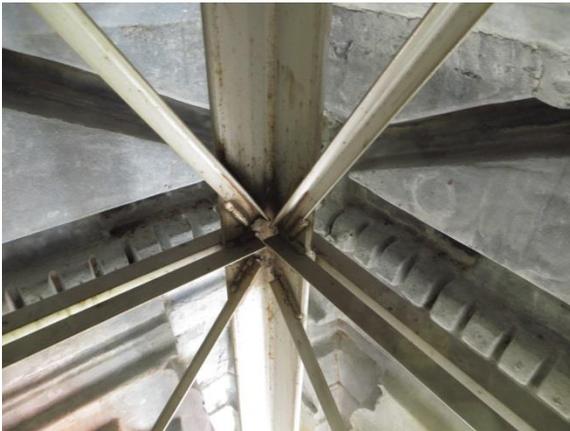
The armature is in good condition. The monument is not watertight, as witnessed by the copious amounts of moisture inside on the day of the survey, which was rainy. The stainless material appears to be weathering well.

Interior view of stainless tower: typical connection between main vertical 3x3 leg, horizontal and diagonal members.

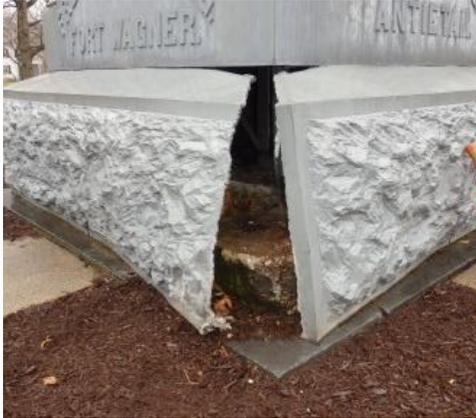
Northwest Corner

Section 1 is 8' square in plan and 30" high. It is suffering from extreme deterioration and deformation. The northwest corner of this section is completely torn. The north and west faces are also substantially deformed. There are substantial tears at the other three corners and multiple smaller tears radiating from edges of the Section at all four sides.

In the absence of prior documentation, there was no way of knowing that the deterioration of Section 1 would advance as dramatically as it has. This deterioration will continue if Section 1 is not freed from the concrete slab at its interior.

From a conservation standpoint, we favor repair of the pieces of Section 1 in order to retain as much original material as possible. Repair could be accomplished by welding with zinc rod. Since the north and west sides of Section 1 have been bent outward, a welded repair will be contingent on the ability to bend the massive north and west sides back to straight. A combination of heating and bending may succeed in straightening these faces.

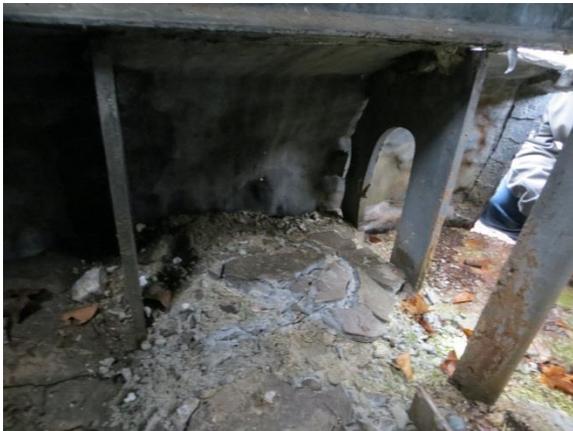
The concrete of the slab is deteriorated. At the open northwest corner it has begun to spall and crumble, likely due to the increased exposure. The top face is extensively cracked.

View from interior looking northwest, Section 1. Note the deteriorated slab and bound stiffener plates.

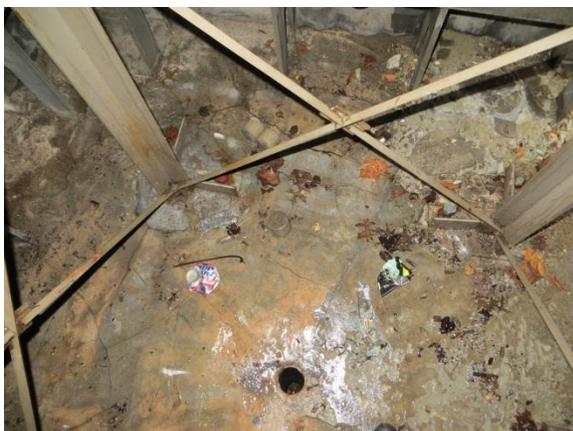
The 1987 restoration efforts initially called for a concrete repair topping to be installed over the existing concrete and sloped to the outside to encourage drainage. Instead, the new topping was sloped to the center and a 2" diameter hole was cored into the center of the base. At the time of the Grissom report (1989) the depth of the hole was measured at 38". Currently, the hole measures 10" deep and is full of debris.

View of concrete slab showing drainage hole and extensive network cracking at surface of slab.

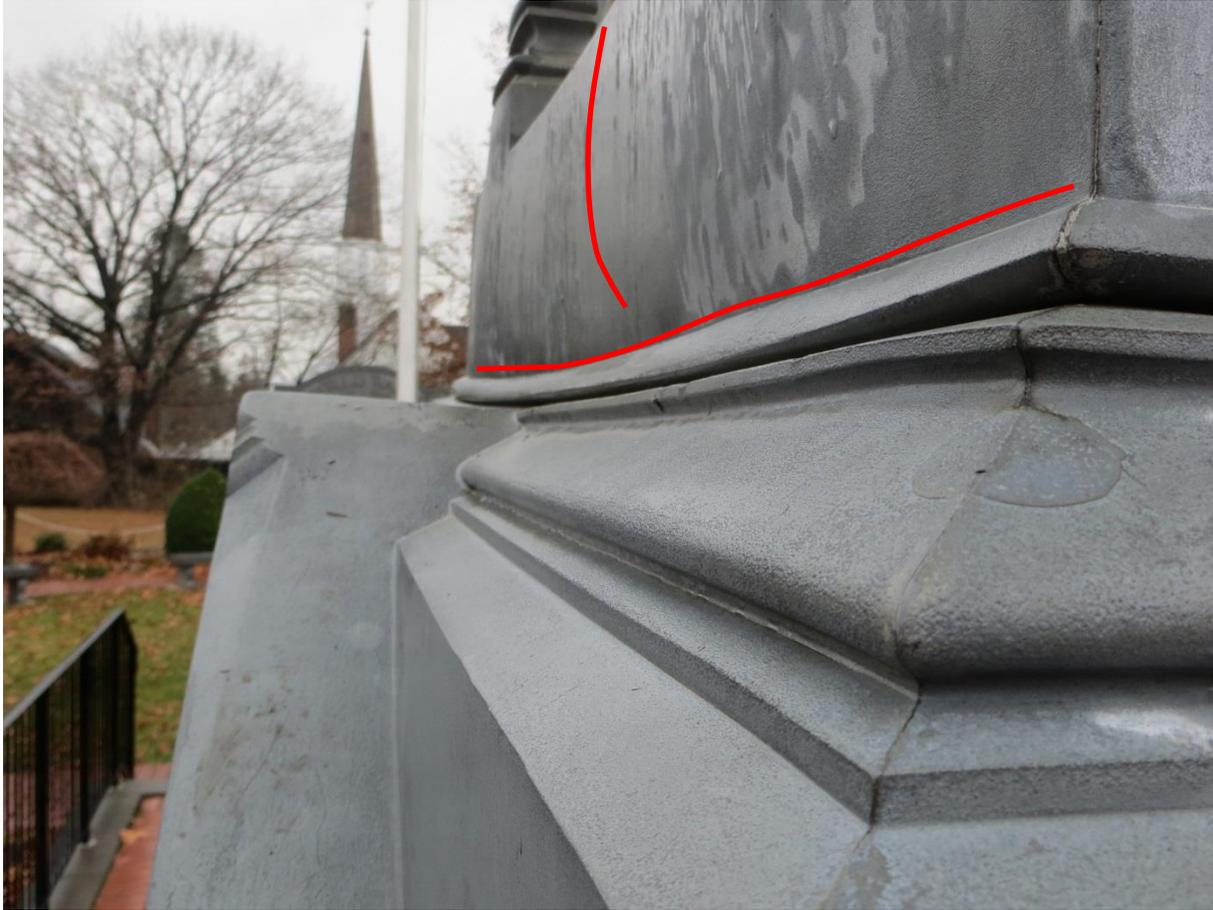
Creep is evident at Academy Hill Monument. It has been documented at other monuments, including those fabricated by The Monumental Bronze Company.

View of south face of joint between Sections 2 and 3A, looking west. Note the bowing of the vertical face of Section 3A at the top of the photo (vertical red line) and the deformation of the long lower edge where it meets Section 2 (horizontal red line). Note that Section 3A bears directly on Section 2, which is supported by vertical posts that bear on its internal corners. One of those corners is in the foreground of this photo.

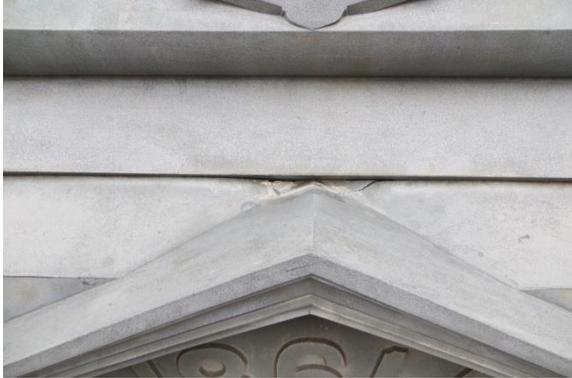
Tear at Section 3A

At the southern side, the connection between pieces 3A and 3B has produced a tear in piece 3A around the tab that holds the internal connector bolt. There is evidence of a previous repair at this location.

This tear is an indicator of the differential movement in the monument. Note that section 3B is supported by the stainless tower, but section 3A is not. Section 3B is moving with the tower, while the section mated to it (3A) is not. Decoupling of sections will aid in alleviating this type of damage.

Exterior view, south face, joint between  
Sections 3A and 3B showing tear at connection  
point.

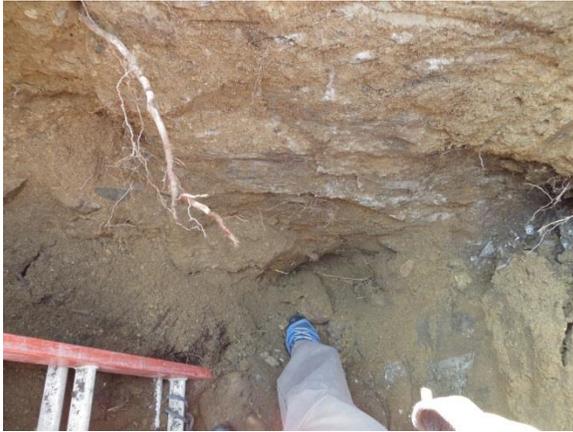
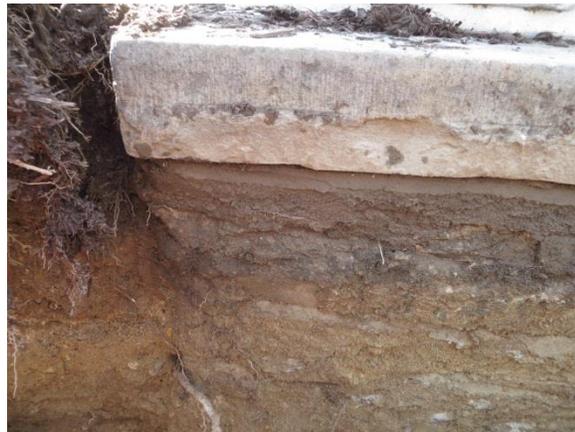
The pit was dug to a depth of five feet. The monument contains a well-laid rubble stone foundation with vertical sides, running to a depth of at least five feet, well below frost depth. The revealed portion of the foundation appeared to be in good condition. The mortar and stone do not exhibit signs of deterioration. While the thickness of the foundation walls is not known due to the presence of the interior concrete, the original zinc posts that support section 2 would have required some base, so it is possible that the foundation extends in to the monument interior at least as far as those posts. The existing foundation is likely sufficient to support sections 1 and 2, and was likely designed to support the entire monument and original armature.

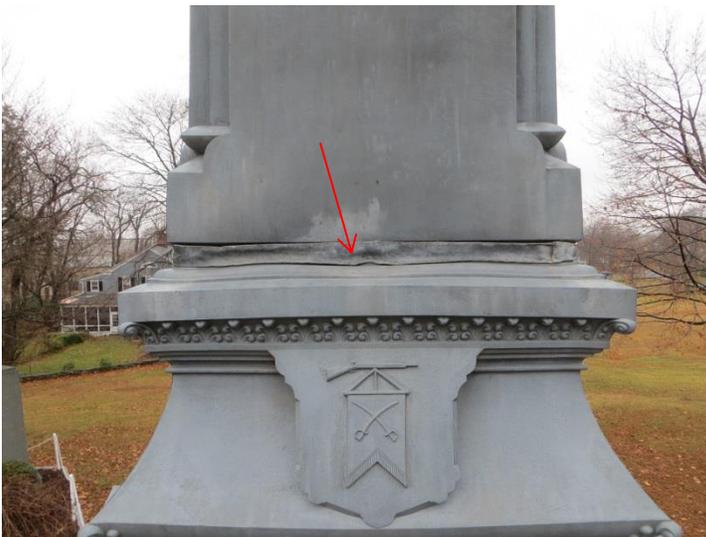
Exterior view, south face, joint  
between Sections 3B and 4 showing  
lead used to fill gap

**III. Disassemble and reassemble monument on site, reusing existing stainless steel armature.** Increase support to the monument on the existing armature to lessen the need for the monument to be self-supporting, thereby decreasing the rate of ongoing deterioration. This would entail decoupling the monument sections and installing new stainless steel elements off the existing armature to support each section of the monument separately. Creating an open joint between the sections would allow for the expansion and contraction of the zinc sections independent of one another, thereby eliminating the need for any section to bear any weight but its own, regardless of the time of year. If necessary, existing gaps between sections that create a poor appearance would be covered with lead as is currently done between Sections 3B and 4.
